Manhole Inspection Summary

Manhole # S17K1_005MH

Location Address: **2691 gable av**

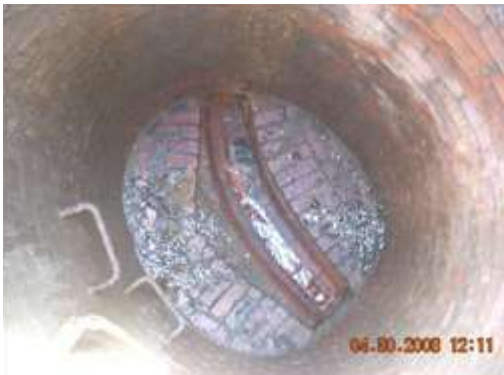
Defect 4

bench debris

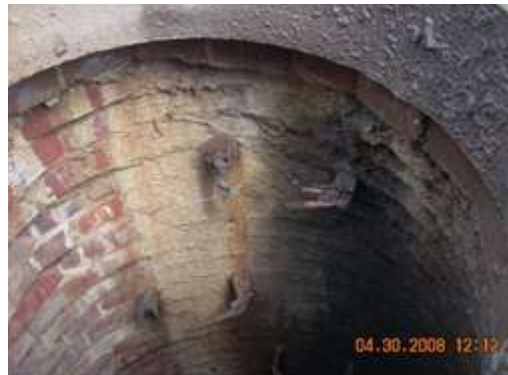
Defect 3

Frame Offset: **1** (in.) Condition: ☐ Sound ☐ Cracked ☒ **Leaks**

Infiltration: ☐ None ☒ **Joint** ☐ Cracks ☐ Mortar ☐ Roots ☐ Wall

infiltration @ chimney/frame joint

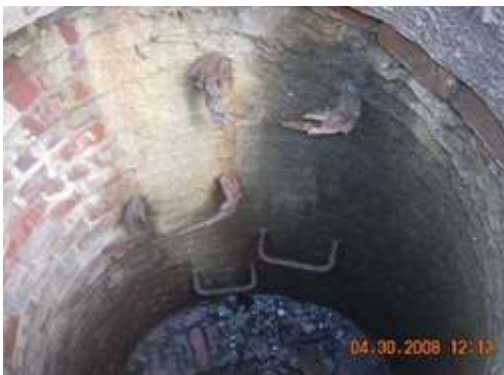
Defect 2

Steps Count: **2** Missing: **2** ☒ **Corroded**

corroded and missing steps

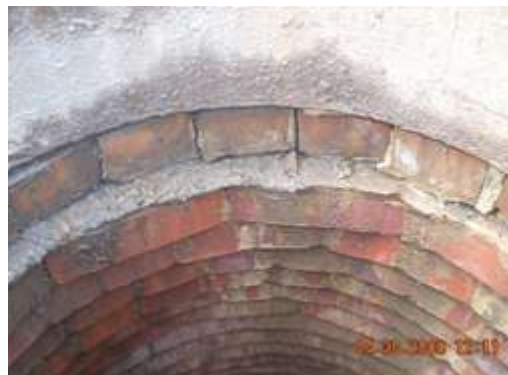
Defect 1

Condition: ☐ Sound ☐ Cracked ☐ Root Intrusion ☒ **Loose Brick** ☐ Deteriorated

chimney loose bricks, inflow from sheeting

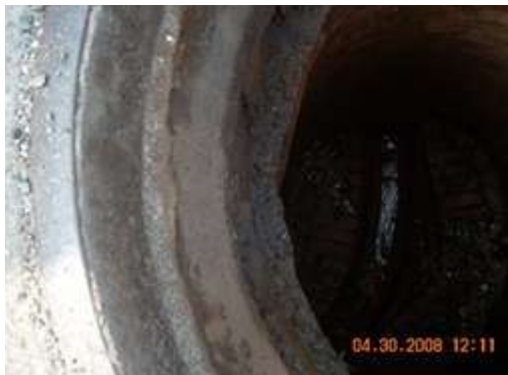
frame offset

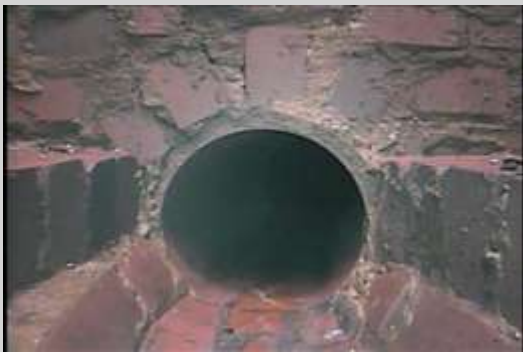
12 O'Clock Outflow

8 in. Circular Gravity Sewer
Pipe Out @ 12 O'Clock

Pipe Height: **8.4** (in.) Rod and Bar (Angled)
Pipe Material: **Clay** ☐ Pipe Lined
Invert Depth: **8.59** (ft.) Flow Characteristics: **Slow**
Deposits: ☒ None ☐ Mud ☐ Sludge ☐ Debris ☐ Grease
Silt Depth: **0** (in.) Deposits Extent:
Infiltration: **None** Pipe Seal Cond: **Sound**

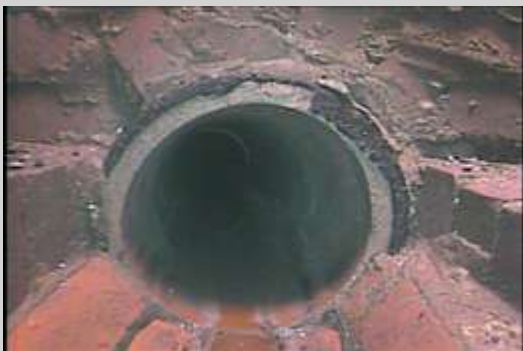
5 O'Clock Inflow

8 in. Circular Gravity Sewer
Pipe In @ 5 O'Clock

Pipe Height: **8.4** (in.) Rod and Bar (Angled)
Pipe Material: **Clay** ☐ Pipe Lined
Invert Depth: **8.34** (ft.) Flow Characteristics: **Slow**
Deposits: ☒ None ☐ Mud ☐ Sludge ☐ Debris ☐ Grease
Silt Depth: **0** (in.) Deposits Extent:
Infiltration: **None** Pipe Seal Cond: **Sound**
